Town of Arlington, Massachusetts

PART A – Executive Summary Self- Evaluation and Transition Plan

November 2019

Part A – Executive Summary

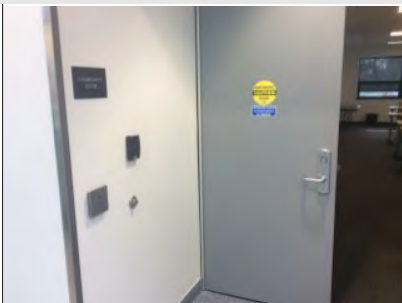
Automatic door opener not operable	-	Repair or replace the door opener.	1	Labor	\$0
Universal Design												
4	Community Room	2	-

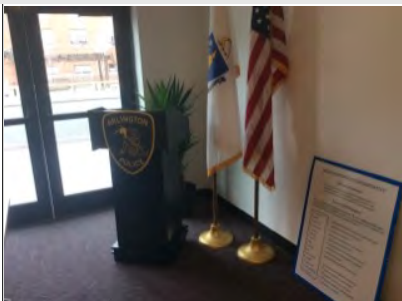
-	Best Practice: Consider providing an adjustable height podium with room for knee and toe clearance.	1		\$0

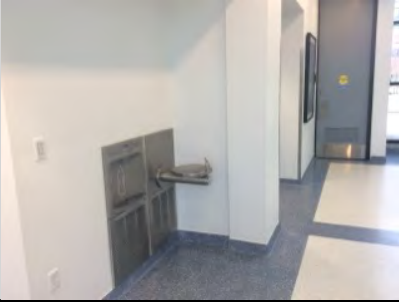
ID	Location	Floor	Room	Element	Type	Photo	Issues	Current Measure	Recommendations	Quantity	Price	Cost Estimation
Additional Access												
5	Drinking Fountains Near Community Room	2	-	Drinking Fountains	N/A

Clear floor space not provided	-	Provide a 30" by 48" clear floor space positioned for a forward approach at the low drinking fountain. Reverse the drinking fountain and the water bottle filling station.	1	1014	\$1014
Access to Goods and Services												
6	Emergency Exit To Pavillion	2	-	Means of Egress	N/A

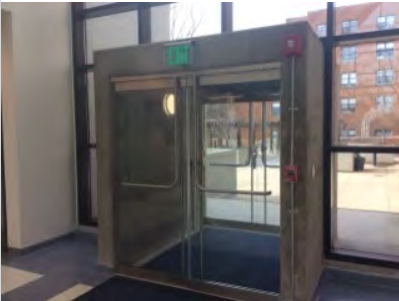
Tactile exit sign not provided	-	Ensure tactile exit signs with raised characters and braille are provided at exit doors. Mount signs between 48"- 60" above finish floor located on the latch side of the door.	1	116	\$116
Access to Goods and Services												
7	Exit In Community Room	2	-	Means of Egress	N/A

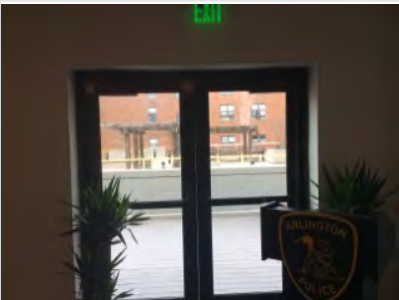
Tactile exit sign not provided	-	Ensure tactile exit signs with raised characters and braille are provided at exit doors. Mount signs between 48"- 60" above finish floor located on the latch side of the door.	1	116	\$116

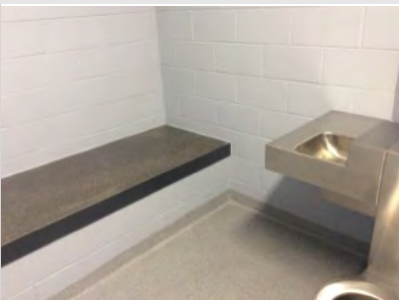
Access to Goods and Services												
8	Holding Cell	2	-	Detention Facilities	Other

Mobility cell bench is not accessible		Ensure that a bench that is 42" long min. and between 20"- 24" deep is provided. Ensure that a 30" by 48" clear floor space positioned at the end of the bench is provided.	1	220	\$220

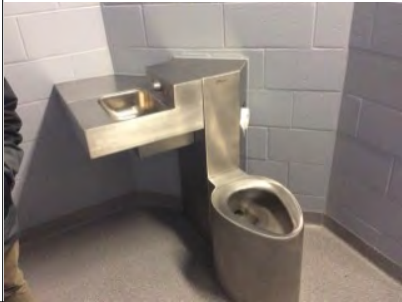
ID	Location	Floor	Room	Element	Type	Photo	Issues	Current Measure	Recommendations	Quantity	Price	Cost Estimation
Access to Goods and Services												
9	Holding Cell Toilet	2	-	Detention Facilities	Other

Mobility cell lacks access to accessible toilet/lavatory	-	Provide a 42"- long ligature resistant grab bar at the rear of the toilet and one on the side wall.	2	449	\$898
10	Holding Cell Toilet	2	-	Detention Facilities	Other

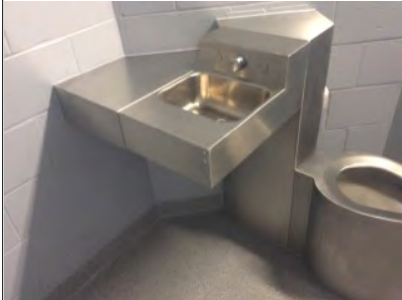
Mobility cell lacks access to accessible toilet/lavatory	30" deep	Ensure an accessible toilet and lavatory is provided. Provide at least one lavatory with a 30" min. by 48" min. clear floor space positioned for a forward approach.	1	5005	\$5005
Toilet & Bathing Rooms												
11	Men's Toilet Room	2	-	Lavatory	N/A

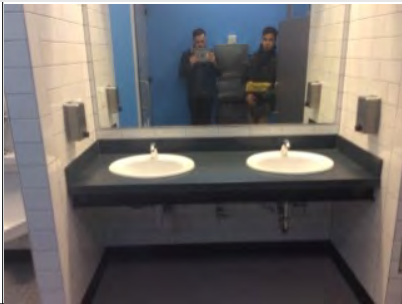
Toe or knee clearances not provided	26.5"	Provide at least one lavatory with knee and toe clearance positioned for a forward approach.	1	843	\$843

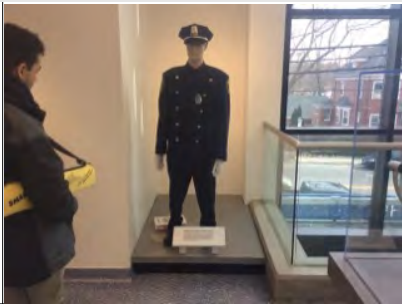
Universal Design												
12	Police Uniform Exhibit	2	-

10"	Consider providing exhibit signage closer to eye level. See the Smithsonian Guidelines for more information: https://www.si.edu/Accessibility/SGAED .	1		\$0

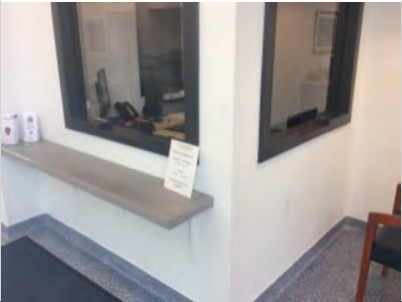
ID	Location	Floor	Room	Element	Type	Photo	Issues	Current Measure	Recommendations	Quantity	Price	Cost Estimation
Access to Goods and Services												
13	Records Desk	2	-	Service Counter	N/A

Counter > 36" high	40"	Provide a counter that is 36" max. above the ground or finish floor.	1	440	\$440
Toilet & Bathing Rooms												
14	Shower In Toilet Room for New Detainees	2	-	Shower Compartment	Alternate

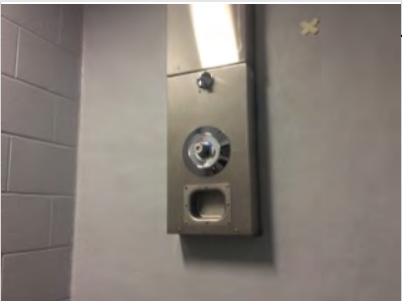
Control height < 38" or > 48"	70"	Relocate controls at 48" max. above the finish floor.	1	289	\$289
Toilet & Bathing Rooms												
15	Toilet Room for New Detainees	2	-	Overall Access	Toilet Room

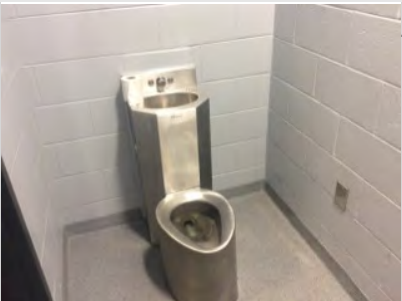
Accessible plumbing fixtures or stalls not provided	50"	Add an accessible single-user toilet room with ligature resistant grab bars and an accessible lavatory.	1	12302	\$12302
Toilet & Bathing Rooms												
16	Women's Toilet Room	2	-	Lavatory	N/A

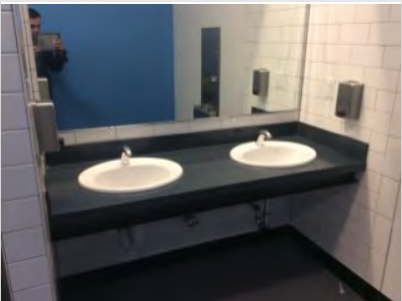
Toe or knee clearances not provided	26.5"	Provide at least one lavatory with knee and toe clearance positioned for a forward approach.	1	843	\$843

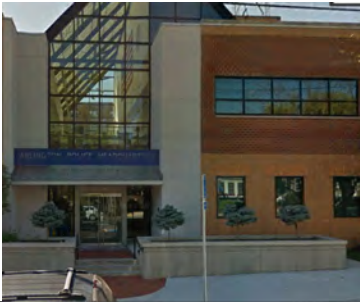
ID	Location	Floor	Room	Element	Type	Photo	Issues	Current Measure	Recommendations	Quantity	Price	Cost Estimation
Universal Design												
17	Main Entrance and Rear Entrance	Ext.	-

Provide an automatic door opener at the main entrance and the rear entrance as people who cannot use their arms may need to get in the building during an emergency or for meetings. Provide a door bell as a back up for times when the automatic door opener is out of service. * (Priority of the Disability Commission)	2	1830	\$3660
Approach and Entrance												
18	Rear Entrance	Ext.	-	Entrance	Secondary Entrance

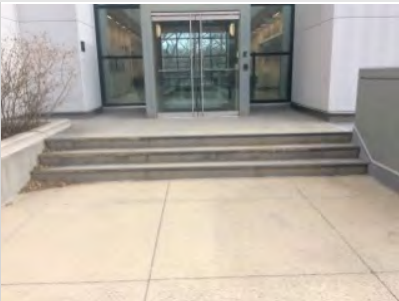
Entrance not on an accessible route Directional sign to accessible entrance not provided	-	Provide a directional sign indicating the location of the nearest accessible entrance. As best practice, locate it at the point where the route becomes inaccessible.	1	173	\$173
Best Practice

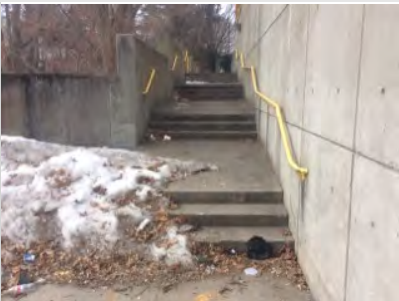
-	Best Practice: Although this is not an accessible route, consider keeping it clear of snow and installing continuous handrails at the lowest stair run. (Cost estimate for pipe rails mounted in concrete: \$460)	1		\$0

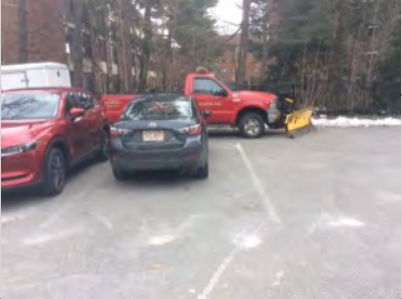
ID	Location	Floor	Room	Element	Type	Photo	Issues	Current Measure	Recommendations	Quantity	Price	Cost Estimation
Approach and Entrance												
Off-Street Parking Lot or Garage												
1	Parking Lot	Ext.		Off-Street Parking Lot or Garage	Visitor

Total # of parking Total # of designated accessible parking spaces Total # of designated van accessible spaces	8 0 0	Provide one van accessible spot with a sign designated "Van Accessible". (Cost estimate for sign, striping and leveling of one van-accessible parking space.) In addition, as best practice, consider locating an accessible on-street parking space near the facility with a compliant curb ramp and clear and level space along the sidewalk.	1	925	\$925
Emergency Exit												
2	Call Counter	1		Emergency Exit	N/A

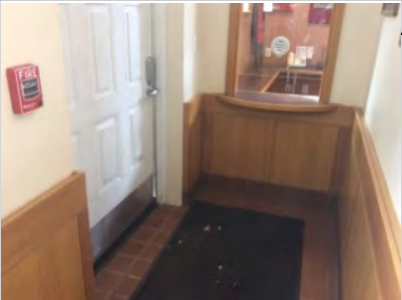
Maneuvering clearance(s) not provided	44"	Provide an automatic door opener.	1	1530	\$1530
Access to Goods and Services

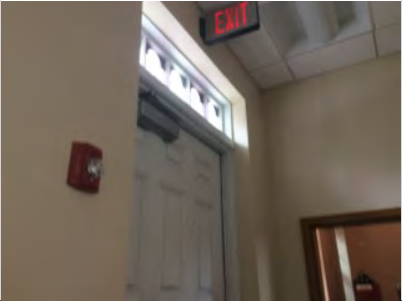
Means of Egress												
3	Main Entrance/ Emergency Exit	1		Means of Egress	N/A

Tactile exit sign not provided	-	Ensure tactile exit signs with raised characters and braille are provided at exit doors. Mount signs between 48"- 60" above finish floor located on the latch side of the door.	1	116	\$116
Doors, Doorways, & Gates												
4	Route To Toilet Room	1		Doors, Doorways, & Gates	Toilet Room

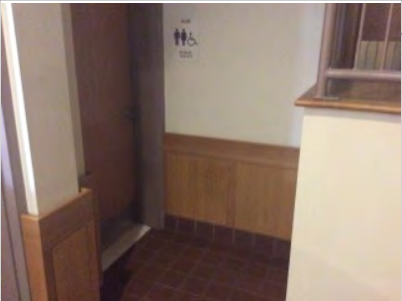
Maneuvering clearance(s) not provided	-	Provide an automatic door opener.	1	1530	\$1530

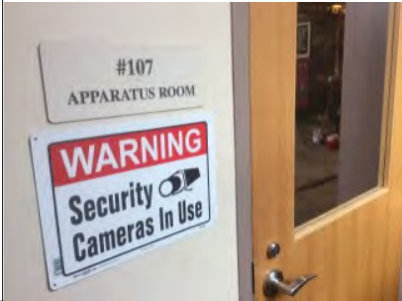
ID	Location	Floor	Room	Element	Type	Photo	Issues	Current Measure	Recommendations	Quantity	Price	Cost Estimation
Signage												
5	Apparatus Room Doors	1	107	Signage	Designation

Raised characters not provided Braille not provided	-	Provide text with raised characters duplicated in braille at room designation signs.	2	116	\$232
Operable Parts												
6	Exterior Main Entrance	Ext.		Operable Parts	Other

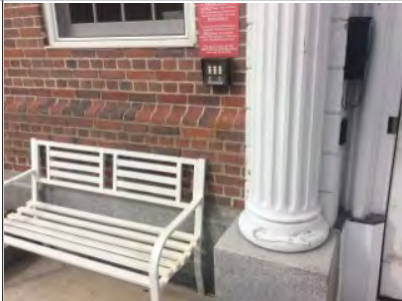
Clear floor space is not provided	-	Provide a 30" min. by 48" min. clear floor space at the call button. Relocate the bench.	1	Labor	\$0
7	Shelf With Flyers	1		Operable Parts	Other

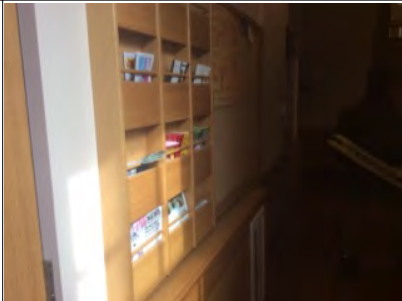
Reach < 15" or > 48"(forward/side approach)	66"	Relocate flyers so that they are between 15"- 48" above finish floor.	1	Labor / 128	\$128
Toilet & Bathing Rooms												
Lavatory												
8	Single-User Toilet Room	1		Lavatory	N/A

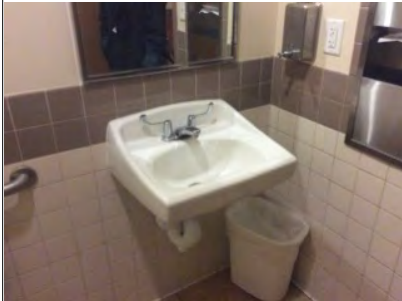
Mirror above lavatory w/reflective surface > 40"	44"	Lower mirror so that the bottom surface is at 40" max. above finish floor.	1	128	\$128

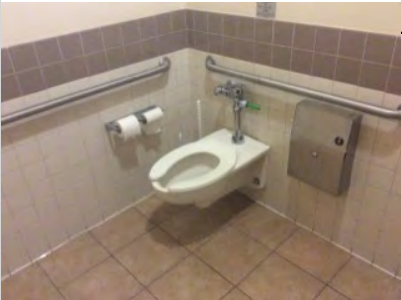
ID	Location	Floor	Room	Element	Type	Photo	Issues	Current Measure	Recommendations	Quantity	Price	Cost Estimation
Single-User Toilet												
9	Single-User Toilet Room	1		Single-User Toilet	N/A

Side or rear grab bar < 33" or > 36" high	31"	Mount grab bars 33"- 36" above the floor.	2	353	\$706
Universal Design												
10	Exterior Main Entrance	Ext.

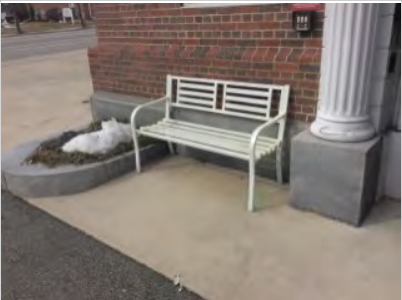
-	Best practice: Relocate bench to ensure it has a 36" x 48" clear floor space alongside it so that a wheelchair user can sit alongside a person sitting in the bench.	1		\$0
Best Practice												
11	Call Counter	1

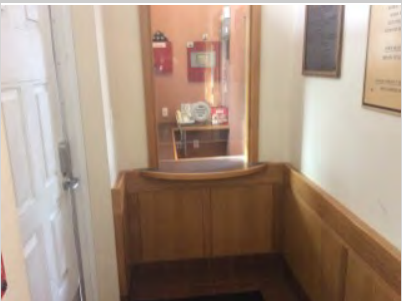
-	Good example of a compliant survey counter.	1		\$0

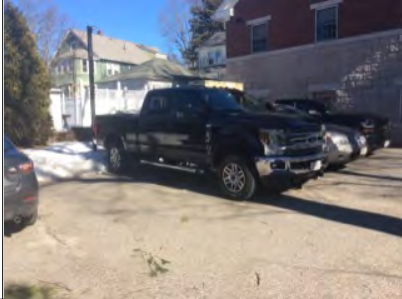
ID	Location	Floor	Room	Element	Type	Photo	Issues	Current Measure	Recommendations	Quantity	Price	Cost Estimation
Approach and Entrance												
Off-Street Parking Lot or Garage												
1	Parking Lot	Ext.		Off-Street Parking Lot or Garage	N/A

Total # of parking Total # of designated accessible parking spaces Total # of designated van accessible spaces	6 0 0	Provide one van-accessible parking space in this lot (Cost estimate for signage, striping and leveling.) Best Practice: Due to the steep slope between the parking lot and the entrance, consider providing a nearby on-street accessible parking space and a compliant curb ramp nearby in addition to the van-accessible parking space in the parking lot.	1	925	\$925
Access to Goods and Services												
Means of Egress												
2	Main Exit	1		Means of Egress	N/A

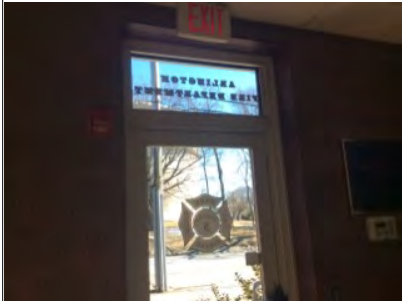
Tactile exit sign not provided		Ensure tactile exit signs with raised characters and braille are provided at exit doors. Mount signs between 48"- 60" above finish floor located on the latch side of the door.	1	116	\$116

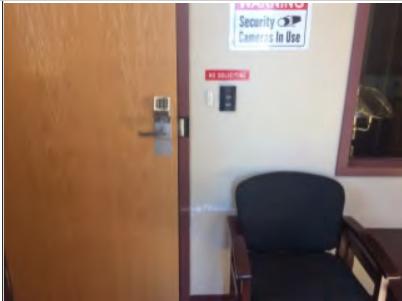
Operable Parts												
3	Waiting Area	1		Operable Parts	Other

Clear floor space is not provided	-	Provide a 30" min. by 48" min. clear floor space at the call button for the fire fighters. Relocate the chair.	1	Labor	\$0

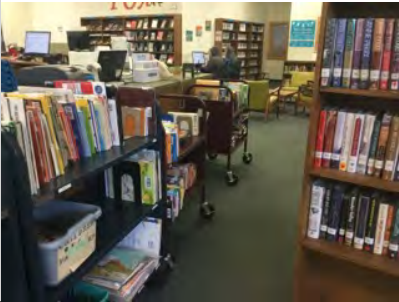
ID	Location	Floor	Room	Element	Type	Photo	Issues	Current Measure	Recommendations	Quantity	Price	Cost Estimation
Access to Goods and Services												
1	Area Next to Service Counter	1		Interior Access Route	N/A

Route < 36" wide	28.5"	Ensure that a clear width of 36" min. is maintained at the accessible route. 521 CMR additionally mentions that a clear width of 42" is preferred at stacks where possible.	1	Labor	\$0
Access to Goods and Services												
2	Computer Stations	1		Dining or Work Surfaces	Work Surface

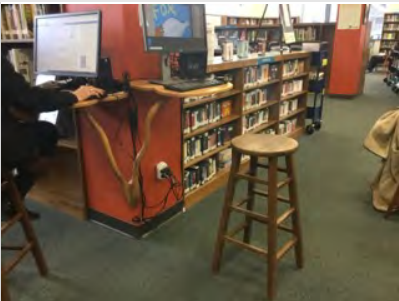
Top of dining/work surface < 28" or > 34"	39"	Provide at least one work surface with tops between 28"- 34" above the floor and 27" clear height underneath.	1	350	\$350
Access to Goods and Services												
3	DVD Shelf and Shelves Throughout Library	1		Operable Parts	Other

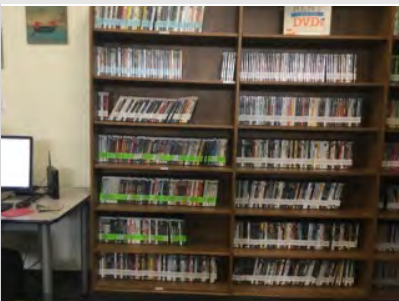
Reach < 15" or > 48"(forward/side approach)	70"	Ensure that staff assists patrons with retrieving material that is located higher than 48" above the finished floor.	1	-	\$0

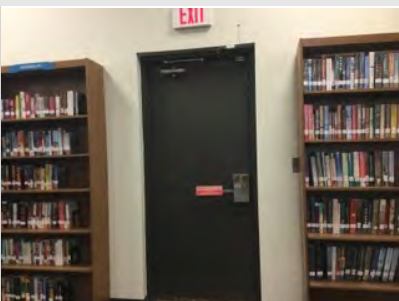
Access to Goods and Services												
4	Main Room	1		Means of Egress	N/A

Tactile exit sign not provided	- -	Ensure tactile exit signs with raised characters and braille are provided at exit doors. Mount signs between 48"- 60" above finish floor located on the latch side of the door.	1	116	\$116

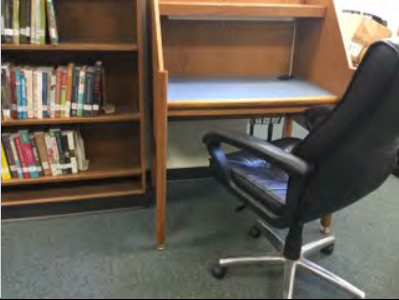
ID	Location	Floor	Room	Element	Type	Photo	Issues	Current Measure	Recommendations	Quantity	Price	Cost Estimation
5	Main Room	1		Dining or Work Surfaces	Work Surface

Knee or toe clearance not provided	26"	Provide at least 1 work surface with 27" min. knee and toe clearance.	1	350	\$350
6	Main Room	1		Dining or Work Surfaces	Work Surface

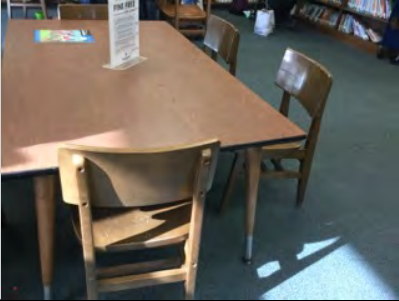
Knee or toe clearance not provided Top of dining/work surface < 28" or > 34"	23.75" 25"	Provide at least 1 dining or work surface with 27" min. knee and toe clearance. Provide at least one dining or work surface with tops between 28"- 34" above the floor and 27" clear height underneath.	1	350	\$350
Additional Access												
7	Main Room	1		Drinking Fountains	Low

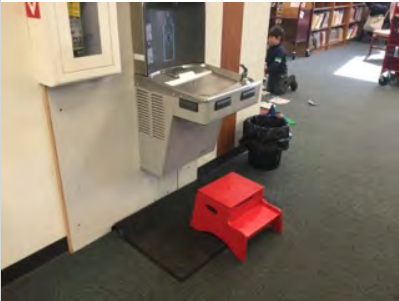
No drinking fountain provided for standing users	-	Provide an additional drinking fountain for standing users.	1	2014	\$2014
Access to Goods and Services												
8	Main Room Northeast Side	1		Interior Access Route	N/A

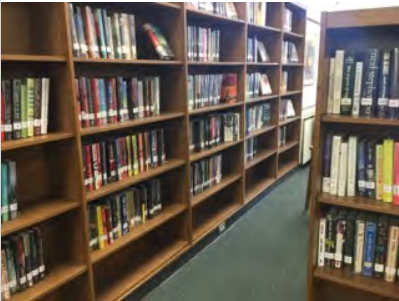
Route < 36" wide	31"	Ensure that a clear width of 36" min. is maintained at the accessible route. 521 CMR additionally mentions that a clear width of 42" is preferred at stacks where possible.	1	Labor	\$0

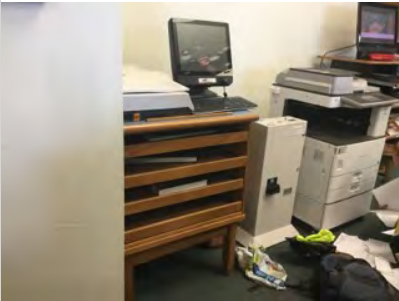
Access to Goods and Services												
9	Printer Area	1		Dining or Work Surfaces	Work Surface

Top of dining/work surface < 28" or > 34"	37"	Provide at least one dining or work surface with tops between 28"- 34" above the floor and 27" clear height underneath.	1	350	\$350

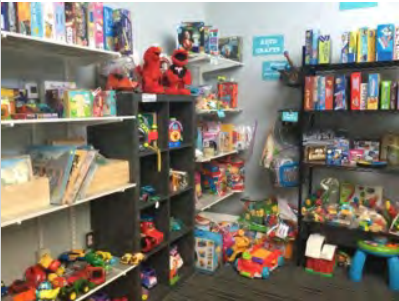
ID	Location	Floor	Room	Element	Type	Photo	Issues	Current Measure	Recommendations	Quantity	Price	Cost Estimation
Access to Goods and Services												
10	Resale Shop	1		Operable Parts	Other

Reach < 15" or > 48"(forward/side approach)	71"	Assist visitors with merchandise that is located higher than 48 above the finished floor in the shop.	1	Labor	\$0
11	Resale Shop	1		Interior Access Route	N/A

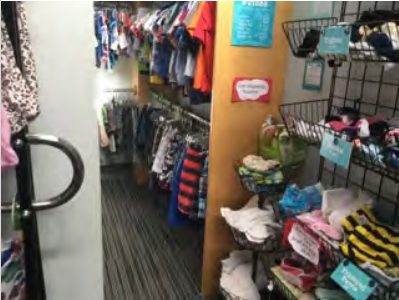
Route < 36" wide	27.5"	Ensure that a clear width of 36" min. is maintained at the accessible route.	1	Labor	\$0
12	Resale Shop	1		Means of Egress	N/A

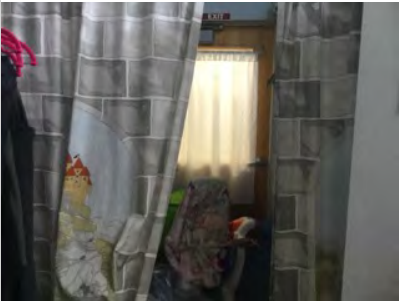
Tactile exit sign not provided	-	Ensure tactile exit signs with raised characters and braille are provided at exit doors. Mount signs between 48"- 60" above finish floor located on the latch side of the door.	1	116	\$116
Access to Goods and Services												
13	Route to Basement	1		Doors, Doorways, & Gates	Circulation

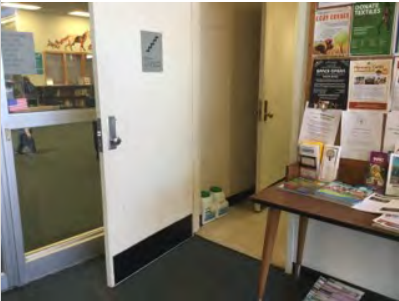
Hardware not operable with a closed fist	-	Provide hardware that can be operable with one hand and not require tight grasping, pinching, or twisting of the wrist.	1	242	\$242

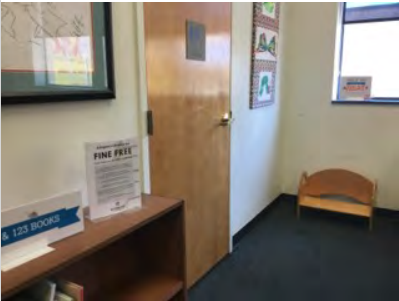
Access to Goods and Services												
14	Single-User Toilet Room	1		Signage	Designation

Sign not located on the latch side of the door	-	Locate sign at permanent rooms alongside the door on the latch side.	1	Labor	\$0

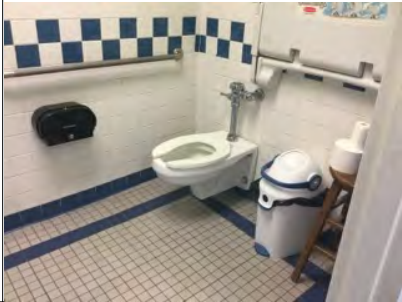
ID	Location	Floor	Room	Element	Type	Photo	Issues	Current Measure	Recommendations	Quantity	Price	Cost Estimation
Toilet & Bathing Rooms												
15	Single-User Toilet Room	1		Single-User Toilet	N/A

Flush control not on open side Grab bar not provided	- -	Relocate the flush control to the open side. Relocate baby changing station in order to provide a 42"-long rear grab bar on the rear wall. Nothing should be mounted over the grab bar.	1	636	\$636
16	Single-User Toilet Room	1		Lavatory	N/A

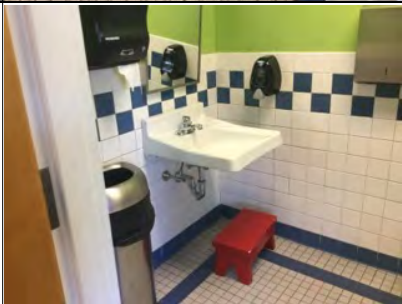
Plumbing underneath is exposed	-	Insulate or otherwise configure pipes to prevent contact at lavatory.	1	46	\$46
Access to Goods and Services												
17	West Emergency Exit	1		Means of Egress	N/A

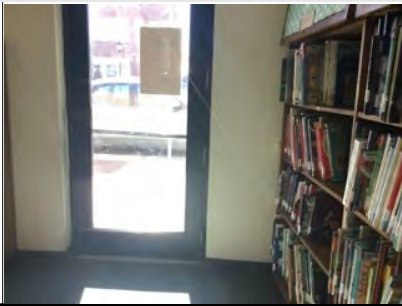
Tactile exit sign not provided	-	Ensure tactile exit signs with raised characters and braille are provided at exit doors. Mount signs between 48"- 60" above finish floor located on the latch side of the door.	1	116	\$116

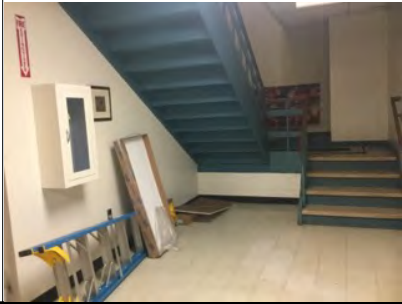
Access to Goods and Services												
18	Basement	B		Interior Access Route	N/A

Obstructed by protruding objects	-	Provide a cane detectable barrier at underside of stair and under fire cabinet. (cost for 6' pipe rail)	1	480	\$480

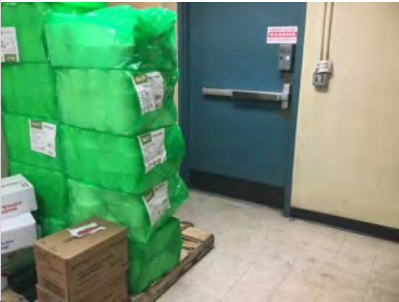
ID	Location	Floor	Room	Element	Type	Photo	Issues	Current Measure	Recommendations	Quantity	Price	Cost Estimation
Approach and Entrance												
19	Basement Emergency Exit	B		Emergency Exit	N/A

Maneuvering clearance(s) not provided	- -	Relocate stored items away from the emergency exit area.	1	Labor	\$0
Access to Goods and Services												
20	Basement Emergency Exit	B		Means of Egress	N/A

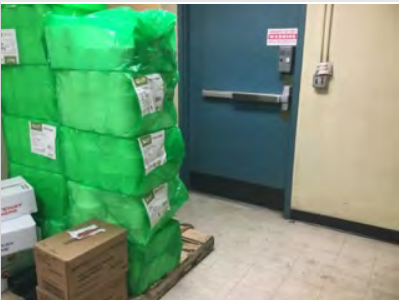
Tactile exit sign not provided	-	Ensure tactile exit signs with raised characters and braille are provided at exit doors. Mount signs between 48"- 60" above finish floor located on the latch side of the door.	1	116	\$116
Access to Goods and Services												
21	Meeting Room	B		Doors, Doorways, & Gates	Meeting Room

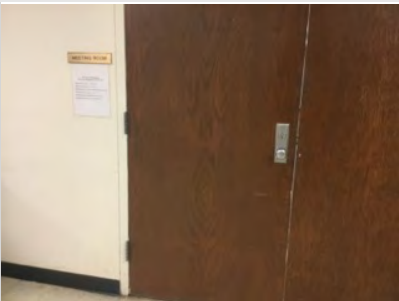
Hardware not operable with a closed fist	-	Provide hardware that can be operable with one hand and not require tight grasping, pinching, or twisting of the wrist.	1	242	\$242

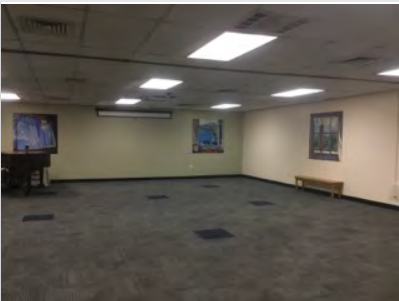
Additional Access												
22	Meeting Room	B		Fire Alarms	N/A

No visible fire alarm provided within room	-	When fire system is updated, ensure that a visible fire alarm is installed in each room.	1	346	\$346

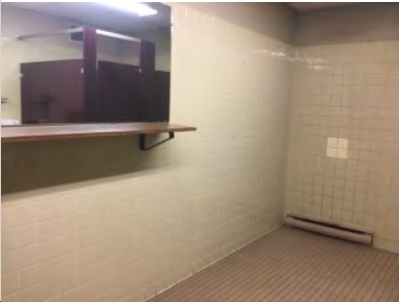
ID	Location	Floor	Room	Element	Type	Photo	Issues	Current Measure	Recommendations	Quantity	Price	Cost Estimation
Access to Goods and Services												
23	Men's Toilet Room	B		Interior Access Route	N/A

Obstructed by protruding objects	11"	Provide a cane detectable barrier on each side of the shelf.	2	153	\$306
Toilet & Bathing Rooms												
24	Men's Toilet Room	B		Overall Access	Toilet Room

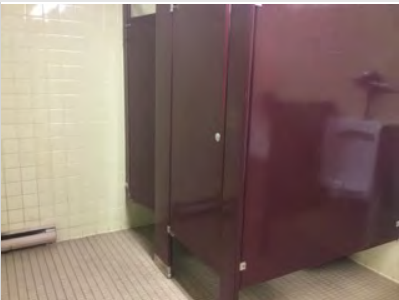
Audible and visible alarms not provided	- -	When fire system is updated, ensure that a visible and audible fire alarm is installed.	1	346	\$346
Access to Goods and Services												
25	Route to Basement Emergency Exit	B		Doors, Doorways, & Gates	Emergency Egress

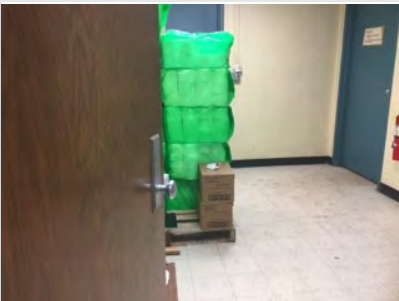
Hardware not operable with a closed fist	-	Provide hardware that can be operable with one hand and not require tight grasping, pinching, or twisting of the wrist.	1	242	\$242
Access to Goods and Services												
26	Stairway	B		Interior Access Route	N/A

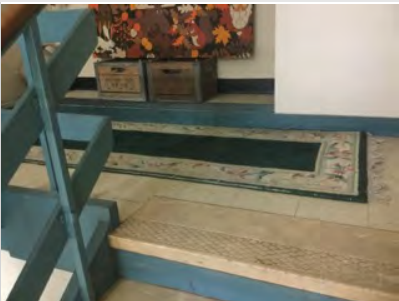
Surface not stable, firm, and slip-resistant	-	Remove carpet from this stairwell.	1	Labor	\$0

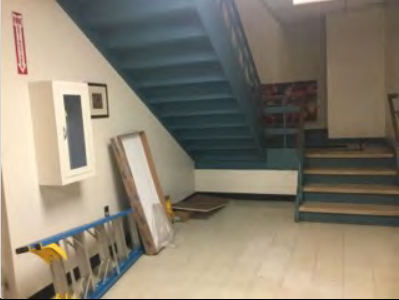
ID	Location	Floor	Room	Element	Type	Photo	Issues	Current Measure	Recommendations	Quantity	Price	Cost Estimation
27	Stairway	B		Interior Access Route	N/A

Accessible route not provided		It may be technically infeasible to provide an elevator or lift to the basement level in the Library. Relocate programs and meetings to the first floor.	1	-	\$0
Access to Goods and Services												
28	Women's Toilet Room	B		Interior Access Route	N/A

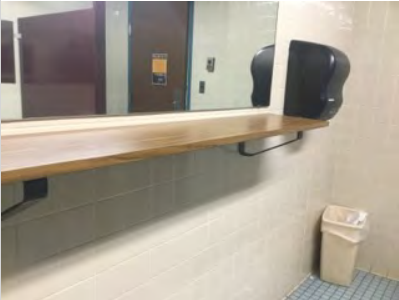
Obstructed by protruding objects	11"	Provide a cane detectable barrier on each side of the shelf.	2	153	\$306
Toilet & Bathing Rooms												
29	Women's Toilet Room	B		Overall Access	Toilet Room

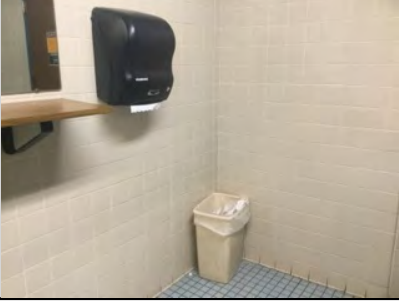
Dispenser acts as a protruding object	8"	Relocate dispenser out of the circulation path.	1	353	\$353

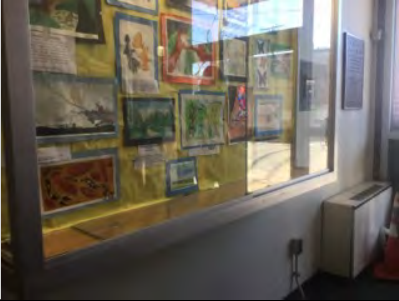
Access to Goods and Services												
31	Main Entrance Corridor	Ext		Interior Access Route	N/A

Obstructed by protruding objects	12.5"	Provide a cane-detectable barrier at each side of the display case.	2	153	\$306

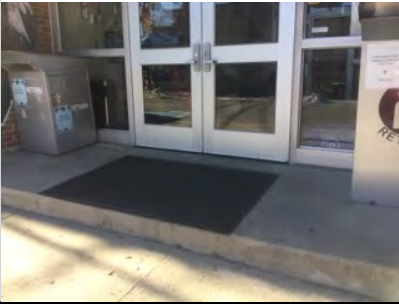
ID	Location	Floor	Room	Element	Type	Photo	Issues	Current Measure	Recommendations	Quantity	Price	Cost Estimation
Approach and Entrance												
32	Main Entrance on Cleveland Street	Ext		Entrance	Main Entrance

Threshold > 1/2" high	8"	Remove exterior door, cut the concrete, and provide a compliant 48"-wide concrete ramp with handrails into this main entrance until renovations are completed to create an accessible entrance on Massachusetts Avenue. Provide an automatic door opener at the entry door.	1	7665	\$7665
Access to Goods and Services												
33	Main Entrance on Cleveland Street	Ext		Means of Egress	N/A

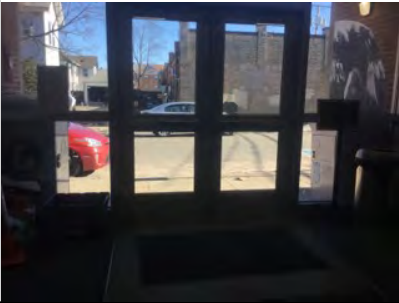
Tactile exit sign not provided	-	Ensure tactile exit signs with raised characters and braille are provided at exit doors. Mount signs between 48"- 60" above finish floor located on the latch side of the door.	1	116	\$116

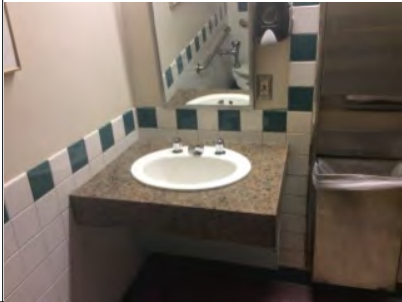
ID	Location	Floor	Room	Element	Type	Photo	Issues	Current Measure	Recommendations	Quantity	Price	Cost Estimation
Toilet & Bathing Rooms												
1	Single-User Toilet Room	1	105	Lavatory	N/A

Toe or knee clearances not provided	26"	Provide at least one lavatory with knee and toe clearance positioned for a forward approach.	1	843	\$843
2	Single-User Toilet Room	1	105	Single-User Toilet	N/A

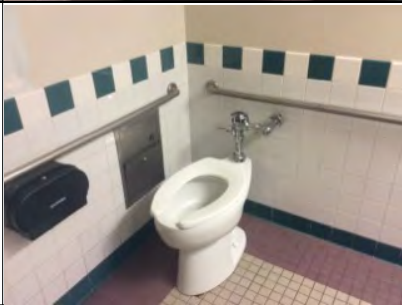
Flush control not on open side Centerline < or > 18" (MAAB)	- 15.5"	Relocate the flush control to the open side. Relocate toilet so that the centerline is 18" from the side wall.	1	1601	\$1601
Access to Goods and Services												
3	Fiction Wing Computer Desks	1	109	Dining or Work Surfaces	Work Surface

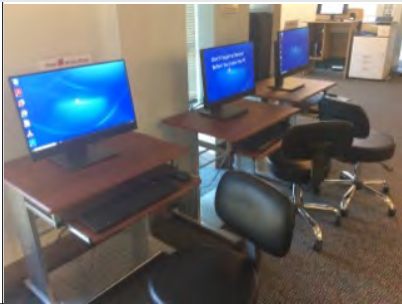
Knee or toe clearance not provided	25"	Provide at least 1 work surface with 27" min. knee and toe clearance.	1	350	\$350
Access to Goods and Services												
4	Fiction Wing Emergency Exit	1	109	Signage	Egress

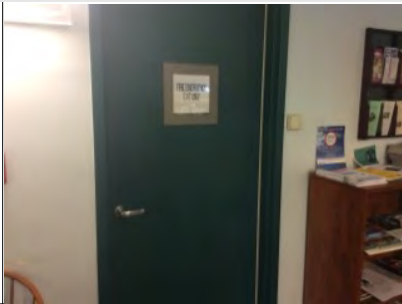
Raised characters not provided Braille not provided	- -	Provide text with raised characters duplicated in braille.	1	116	\$116

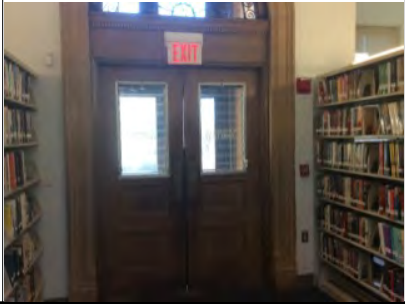
ID	Location	Floor	Room	Element	Type	Photo	Issues	Current Measure	Recommendations	Quantity	Price	Cost Estimation
Access to Goods and Services												
5	Fiction Wing, Double Door Exit	1	110	Means of Egress	N/A

Tactile exit sign not provided	-	Ensure tactile exit signs with raised characters and braille are provided at exit doors. Mount signs between 48"- 60" above finish floor located on the latch side of the door.	1	116	\$116
Access to Goods and Services												
6	Reading Room Tables	1	111	Dining or Work Surfaces	Work Surface

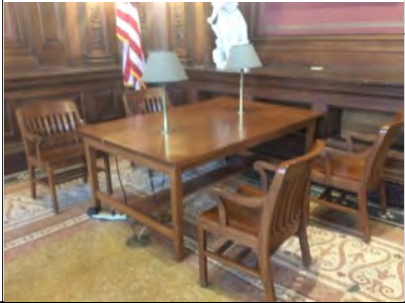
Knee or toe clearance not provided	25"	Provide at least 1 work surface with 27" min. knee and toe clearance.	1	350	\$350
Access to Goods and Services												
7	Printing Station Behind Info Desk	1	113	Dining or Work Surfaces	Work Surface

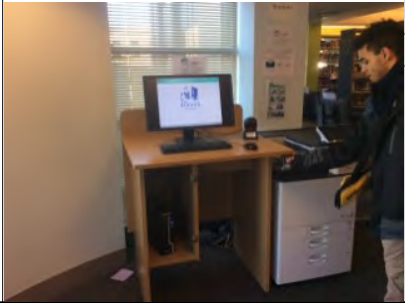
Knee or toe clearance not provided Top of dining/work surface < 28" or > 34"	- 39"	Provide at least 1 work surface with 27" min. knee and toe clearance. Work surface should have tops between 28"- 34" above the floor and 27" clear height underneath.	1	350	\$350

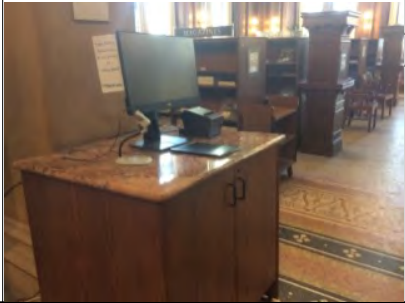
Access to Goods and Services												
8	Self-Checkout Counter Next to Reading Room	1	114	Dining or Work Surfaces	Work Surface

Knee or toe clearance not provided Top of dining/work surface < 28" or > 34"	- 39"	Provide at least 1 work surface with 27" min. knee and toe clearance. Work surface should have tops between 28"- 34" above the floor and 27" clear height underneath.	1	350	\$350

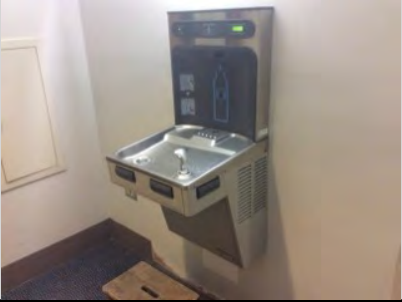
ID	Location	Floor	Room	Element	Type	Photo	Issues	Current Measure	Recommendations	Quantity	Price	Cost Estimation
Additional Access												
9	Corridor by Toilet Rooms	1	119	Drinking Fountains	N/A

Standing height fountain does not have cane protection No drinking fountain provided for seated users	- -	Provide an additional drinking fountain for seated users or install a Hi-Lo drinking fountain. Provide a cane detectable barrier skirt under the high unit.	1	2459	\$2459
Access to Goods and Services												
10	Administration Offices	2	205	Signage	Designation

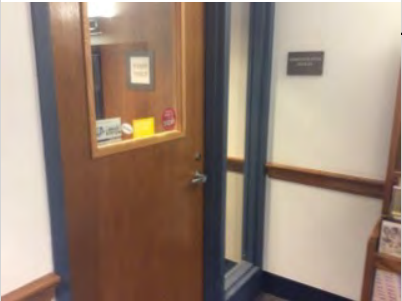
Sign not located on the latch side of the door	-	Locate sign at permanent rooms alongside the door on the latch side.	1	Labor	\$0
Access to Goods and Services												
11	Cataloging Station	2	209	Dining or Work Surfaces	Work Surface

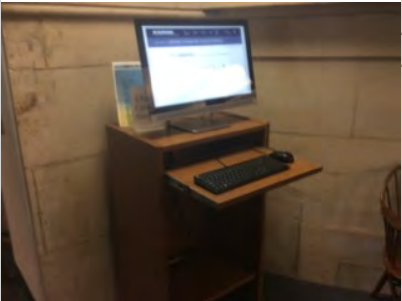
Knee or toe clearance not provided Top of dining/work surface < 28" or > 34"	- 37"	Provide at least 1 work surface with 27" min. knee and toe clearance. Work surface should have tops between 28"- 34" above the floor and 27" clear height underneath.	1	350	\$350

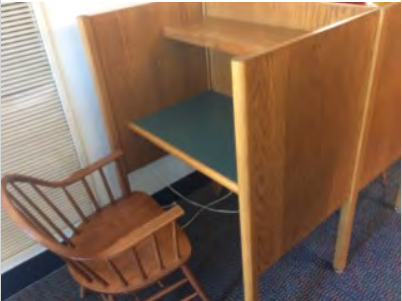
Best Practice												
12	Study Carrels	2	209

-	Best Practice: These are good examples of accessible study carrels.

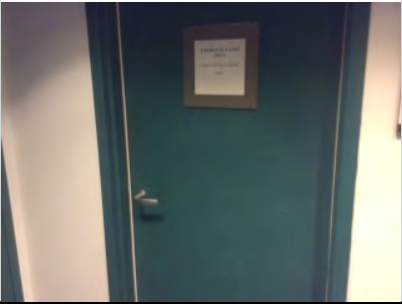
ID	Location	Floor	Room	Element	Type	Photo	Issues	Current Measure	Recommendations	Quantity	Price	Cost Estimation
Access to Goods and Services												
13	Emergency Exit in Nonfiction Wing	3	301	Means of Egress	N/A

Tactile exit sign not provided	-	Ensure tactile exit signs with raised characters and braille are provided at exit doors. Mount signs between 48"- 60" above finish floor located on the latch side of the door.	1	116	\$116
Access to Goods and Services												
14	Outdoor Apiary	3	301	Signage	Designation

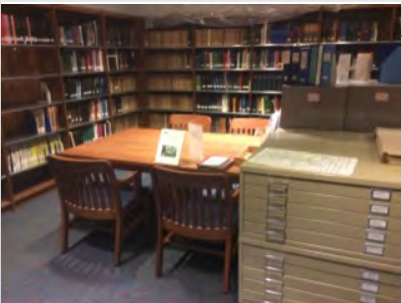
Knee or toe clearance not provided	26"	Provide at least 1 work surface with 27" min. knee and toe clearance.	1	350	\$350
Access to Goods and Services

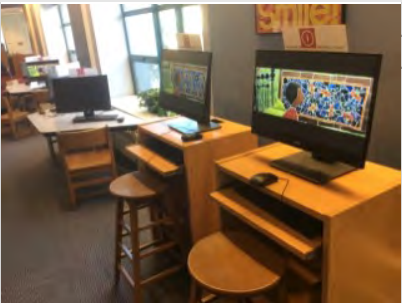
16	Children's Wing	B	007	Dining or Work Surfaces	Work Surface

Knee or toe clearance not provided Top of dining/work surface < 28" or > 34"	- -	Provide at least 1 work surface with 27" min. knee and toe clearance. Work surface should have tops between 28"- 34" above the floor and 27" clear height underneath.	1	350	\$350

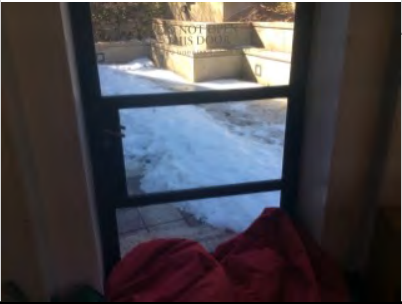
ID	Location	Floor	Room	Element	Type	Photo	Issues	Current Measure	Recommendations	Quantity	Price	Cost Estimation
Access to Goods and Services												
17	Door To Patio	B	007	Signage	Informational

Non glare finish and contrast not provided	-	Provide signs with a non-glare finish with characters that have a high contrast to the background.	1	116	\$116
Toilet Rooms for Children												
18	Children's Toilet Room	B	010	Lavatory	N/A

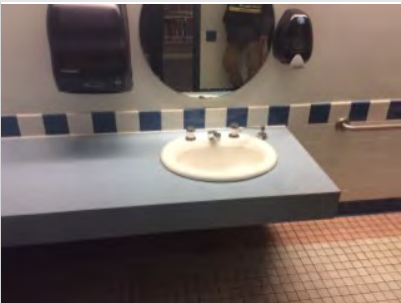
Toe or knee clearances not provided	19"	Provide at least one lavatory with 25" min. knee clearance positioned for a forward approach. Relocate lavatory counter.	1	843	\$843
Access to Goods and Services												
19	Children's Toilet Rooms	B	010,009	Signage	Designation

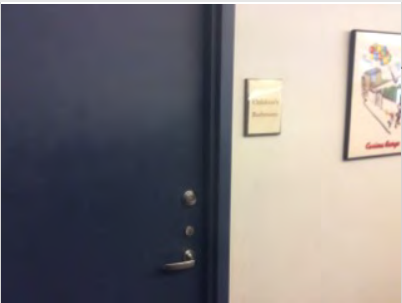
Raised characters not provided Braille not provided	- -	Provide text with raised characters duplicated in braille at both children's toilet rooms. Provide a compliant International Symbol of Accessibility at the toilet room where the lavatory is repositioned to allow toe and knee clearance.	2	116	\$232

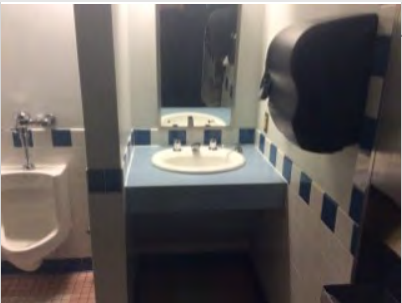
Toilet & Bathing Rooms												
20	Community Room Men's Toilet Room	B	011	Dispensers	Paper Towel Dispenser

Dispenser acts as a protruding object	-	Relocate dispenser out of the circulation path.	1	353	\$353

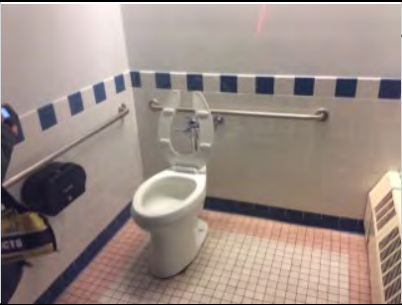
ID	Location	Floor	Room	Element	Type	Photo	Issues	Current Measure	Recommendations	Quantity	Price	Cost Estimation
21	Community Room Men's Toilet Room	B	011	Toilet Compartment	Accessible Compartment

. Flush control not on open side Side or rear grab bar < 33" or >36" high	- 30" -	Locate grab bars between 33"- 36" above the finish floor. Provide the flush control on the open side of the toilet (transfer side).	1	893	\$893
Toilet & Bathing Rooms												
22	Community Room Women's Toilet Room	B	014	Lavatory	N/A

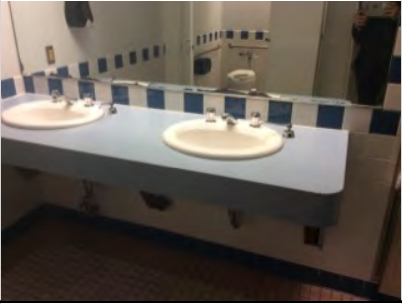
Plumbing underneath is exposed	-	Insulate or otherwise configure pipes to prevent contact, for at least one lavatory.	1	46	\$46
23	Community Room Women's Toilet Room	B	014	Toilet Compartment	Accessible Compartment

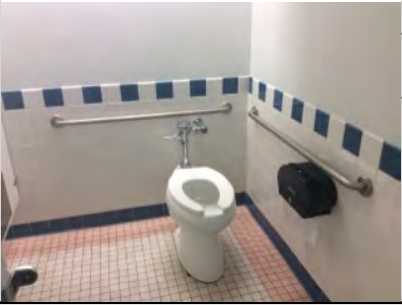
Door has malfunctioning self-closing hinge Side or rear grab bar < 33" or >36" high Coat hook > 48"	- 31" 63"	Repair hinge. Locate grab bars between 33"- 36" above the finish floor. Lower coat hook so that it is no higher than 48".	1	Labor 781	\$781

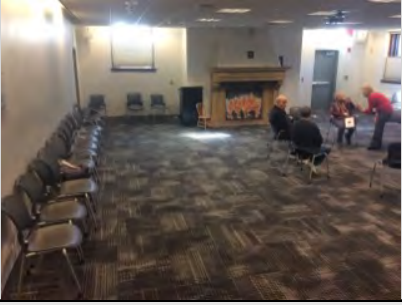
Access to Goods and Services												
24	Community Room	B	016	Assembly Area	N/A

Assistive listening devices not provided	114	If audible communication is integral to the use of the space, provide an assistive listening system.	1	1688	\$1688
Access to Goods and Services												
25	Community Room Emergency Exit	B	016	Means of Egress	N/A

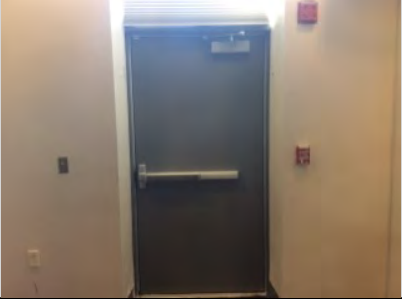
Tactile exit sign not provided	-	Ensure tactile exit signs with raised characters and braille are provided at exit doors. Mount signs between 48"- 60" above finish floor located on the latch side of the door.	1	116	\$116

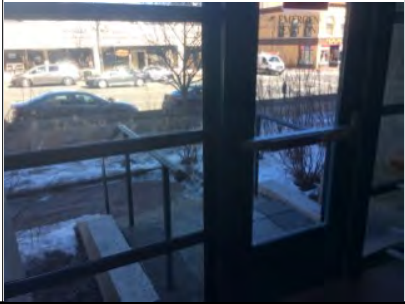
ID	Location	Floor	Room	Element	Type	Photo	Issues	Current Measure	Recommendations	Quantity	Price	Cost Estimation
Access to Goods and Services												
26	Emergency Exit In Stairwell	B	034	Means of Egress	N/A

Tactile exit sign not provided	-	Ensure tactile exit signs with raised characters and braille are provided at exit doors. Mount signs between 48"- 60" above finish floor located on the latch side of the door.	1	116	\$116
Access to Goods and Services												
27	Emergency Exit	Ext	-	Stairways	Exterior

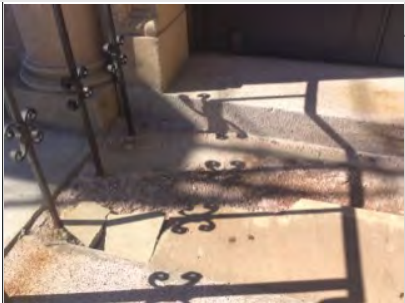
Not maintained in operable working condition	-	Ensure stairs are maintained in operable working condition. Repair pavers.	1	Labor	\$0
Best Practice												
28	Front Entrance Stairs	Ext	-

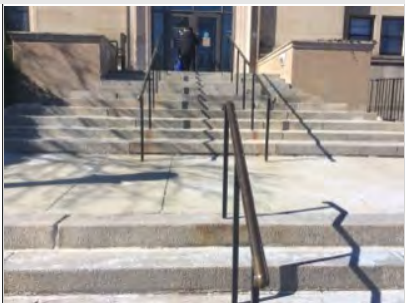
-	Best Practice: Consider providing compliant handrails at the stairs leading to the main entrance. See 521 CMR 27.00 and ADA 2010: 505 for guidance.			
Approach and Entrance

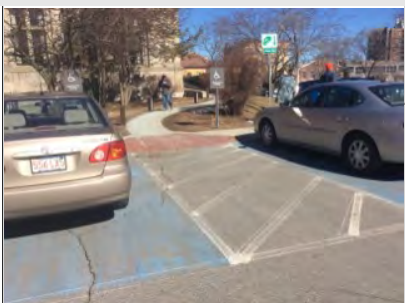
29	Parking Lot	Ext	-	Off-Street Parking Lot or Garage	Visitor

Total # of parking Total # of designated accessible parking spaces Total # of designated van accessible spaces	24 2 0	Convert one accessible parking space to a compliant van-accessible parking space.	1	400	\$400

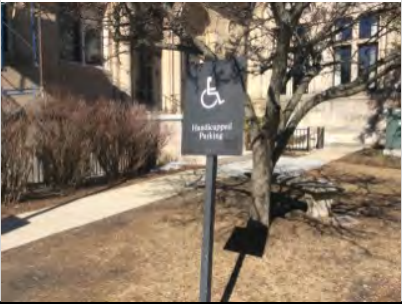
ID	Location	Floor	Room	Element	Type	Photo	Issues	Current Measure	Recommendations	Quantity	Price	Cost Estimation
Universal Design												
30	Parking Lot	Ext	-

Consider changing the outdated wording "Handicapped Parking" to "Accessible Parking" at both parking signs.	2		\$0

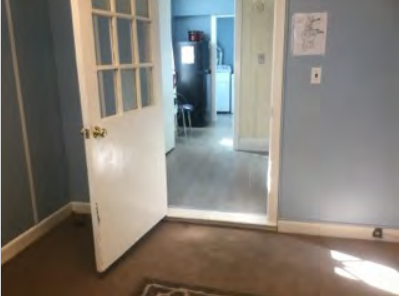
ID	Location	Floor	Room	Element	Type	Photo	Issues	Current Measure	Recommendations	Quantity	Price	Cost Estimation
1	Comfort Room	1		Doors, Doorways, & Gates	Circulation

Threshold > 1/2" high Hardware not operable with a closed fist Maneuvering clearance(s) not provided	2.5" -	Alter threshold to be 1/2" high max. Provide a rubber threshold mat and an automatic door opener. Provide hardware that can be operable with one hand and not require tight grasping, pinching, or twisting of the wrist.	1	1942	\$1942
2	Comfort Room	1		Interior Access Route	N/A

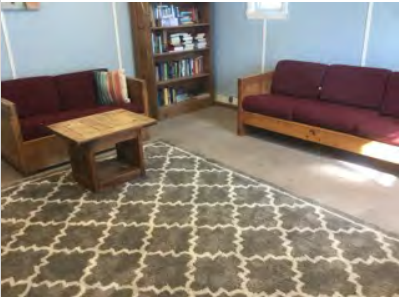
Surface not stable, firm, and slip-resistant		Secure the carpet.	1	Labor	\$0
3	Dining Room (Route by Stairs)	1		Doors, Doorways, & Gates	Circulation

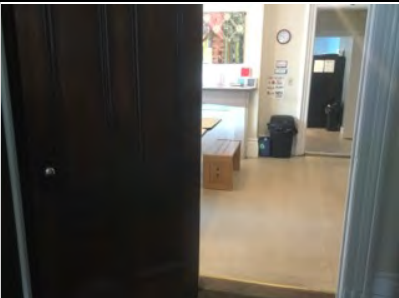
Hardware not operable with a closed fist		Provide hardware that can be operable with one hand and not require tight grasping, pinching, or twisting of the wrist.	1	242	\$242
4	Dining Room to Kitchen	1		Doors, Doorways, & Gates	Circulation

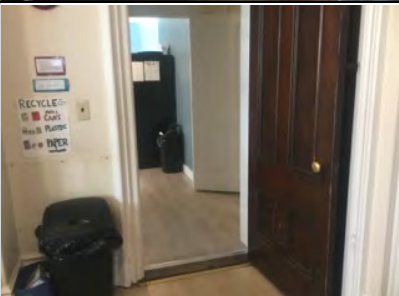
Hardware not operable with a closed fist		Provide hardware that can be operable with one hand and not require tight grasping, pinching, or twisting of the wrist.	1	242	\$242

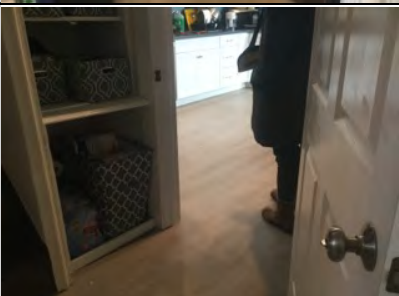
5	Dining Room to Kitchen	1		Doors, Doorways, & Gates	Circulation

Hardware not operable with a closed fist		Provide hardware that can be operable with one hand and not require tight grasping, pinching, or twisting of the wrist.	1	242	\$242

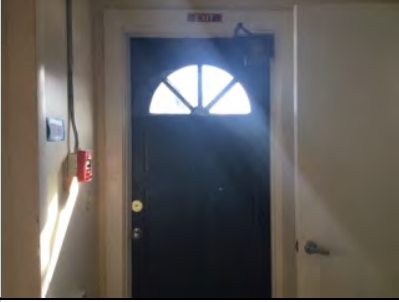
ID	Location	Floor	Room	Element	Type	Photo	Issues	Current Measure	Recommendations	Quantity	Price	Cost Estimation
6	East Side Entrance, Accessible	1		Emergency Exit	N/A

Tactile exit sign not provided International Symbol of Acc. not provided Maneuvering clearance(s) not provided Hardware not operable with a closed fist		Provide a tactile exit sign with raised characters and braille at exit doors. Mount signs between 48"- 60" above finished floor located on the latch side of the door. Provide an illuminated sign with the International Symbol of Accessibility. Provide an automatic door opener. Provide hardware that can be operable with one hand and not require tight grasping, pinching, or twisting of the wrist.	1	2346	\$2346
7	East Side Entrance, Inaccessible	1		Emergency Exit	N/A

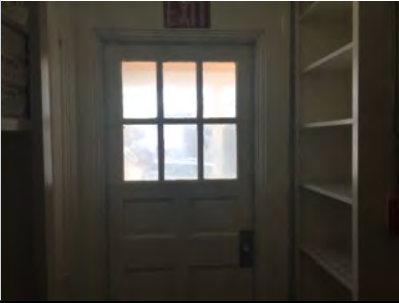
Tactile exit sign not provided Directional sign to accessible emergency exit not provided Hardware not operable with a closed fist		Provide a tactile exit sign with raised characters and braille at exit doors. Mount signs between 48"- 60" above finished floor located on the latch side of the door. Provide a directional sign indicating the location of the nearest emergency exit. Provide hardware that can be operable with one hand and not require tight grasping, pinching, or twisting of the wrist.	1	474	\$474

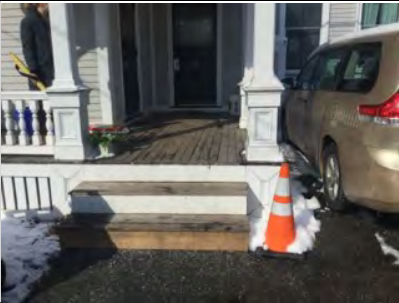
8	East Side Entrance, Inaccessible	1		Entrance	Secondary Entrance

Entrance not on an accessible route Directional sign to accessible entrance not provided Hardware not operable with a closed fist		Provide a directional sign indicating the location of the nearest accessible entrance. Where a directional sign is required, it should be located to minimize backtracking. In some cases, this could mean locating a sign at the beginning of a route, not just at the inaccessible entrances to a building. Provide hardware that can be operable with one hand and not require tight grasping, pinching, or twisting of the wrist.	1	415	\$415
9	First Floor Hallway	1		Operable Parts	Clothes Rod/Hooks

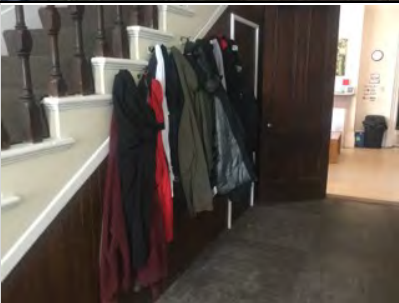
Reach < 15" or > 48"(forward/side approach)	59"	Relocate one hook between 48" max. above the finished floor.	1	128	\$128
10	Front Entrance	1		Emergency Exit	N/A

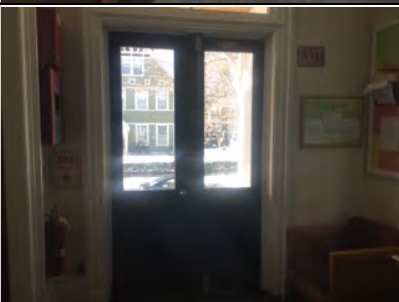
Emergency exit not on an accessible route Tactile exit sign not provided Directional sign to accessible emergency exit not provided If double-leaf door, neither compliant	- - - 27"	Provide a directional sign indicating the location of the nearest emergency exit. Provide a tactile exit sign with raised characters and braille at exit doors. Mount signs between 48"- 60" above finished floor located on the latch side of the door. Ensure that at least one of the active leaves is at least 32" min. wide.	1	1762	\$1762

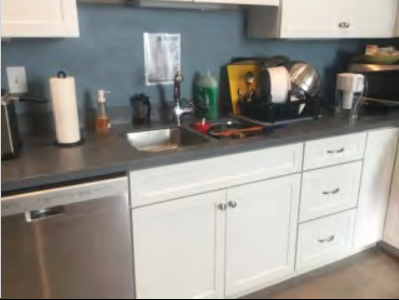
ID	Location	Floor	Room	Element	Type	Photo	Issues	Current Measure	Recommendations	Quantity	Price	Cost Estimation
11	Kitchen	1		Kitchens and Kitchenettes	Other

Knee/toe clearance not provided at sink Sink > 34" high Countertop next to sink < 15" wide	- 36" 0"	Provide a sink with knee and toe clearance positioned for a forward approach. Lower sink to be no higher than 34" positioned for a forward approach. Ensure a countertop that is at least 15" wide with knee and toe clearance is provided next to the sink.	1	2007	\$2007
12	Kitchen	1		Kitchens and Kitchenettes	Other

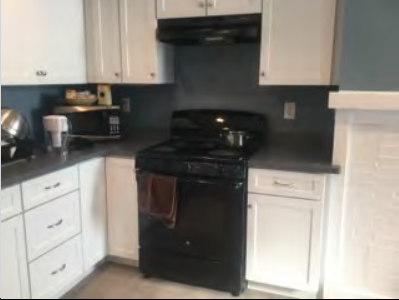
Knee/toe clearance not provided at cooktop Countertop next to cooktop < 15" wide Wall oven type not provided Hood controls > 48"	- - - 67"	Provide a cooktop with knee and toe clearance positioned for a forward approach. Ensure a countertop that is at least 15" wide is provided next to the cooktop. Ensure that a wall type oven is provided. Lower the hood controls to 48" max. above the finished floor.	1	2188	\$2188

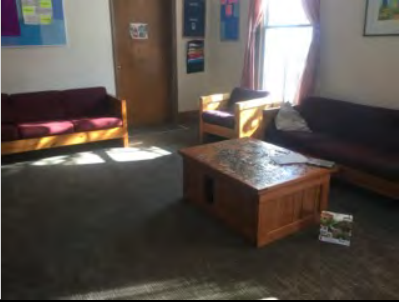
13	Living Room and Comfort Room	1		Fire Alarms	Other

No visible fire alarm provided within room		When fire system is updated, ensure that a visible fire alarm is installed in each room.	2	346	\$692
14	Living Room to First Floor Hallway	1		Doors, Doorways, & Gates	Circulation

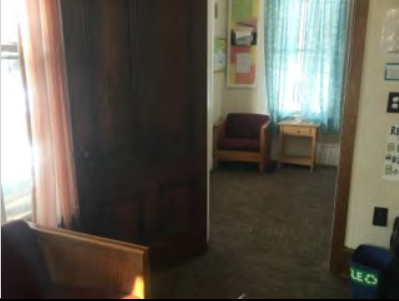
Hardware not operable with a closed fist		Provide hardware that can be operable with one hand and not require tight grasping, pinching, or twisting of the wrist.	1	242	\$242
15	Office	1		Doors, Doorways, & Gates	Office

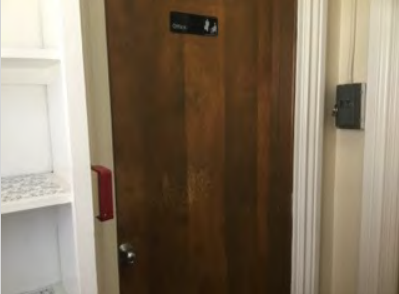
Hardware not operable with a closed fist		Provide hardware that can be operable with one hand and not require tight grasping, pinching, or twisting of the wrist.	1	242	\$242

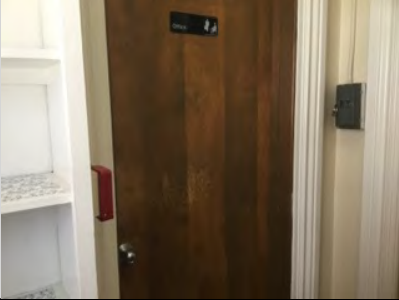
ID	Location	Floor	Room	Element	Type	Photo	Issues	Current Measure	Recommendations	Quantity	Price	Cost Estimation
16	Office	1		Signage	Designation

Raised characters not provided Braille not provided Sign not located on the latch side of the door		Provide text with raised characters duplicated in braille. Locate sign at permanent rooms alongside the door on the latch side.	1	116 Labor	\$116
17	Parking Lot	1		Off-Street Parking Lot or Garage
